**COMPENDIUM OF  
GRID DISTURBANCES  
AND EVENTS – 2025**

**MAHARASHTRA POWER SYSTEM**

**MAHARASHTRA STATE LOAD DESPATCH CENTRE (MSLDC)**

January - December 2025

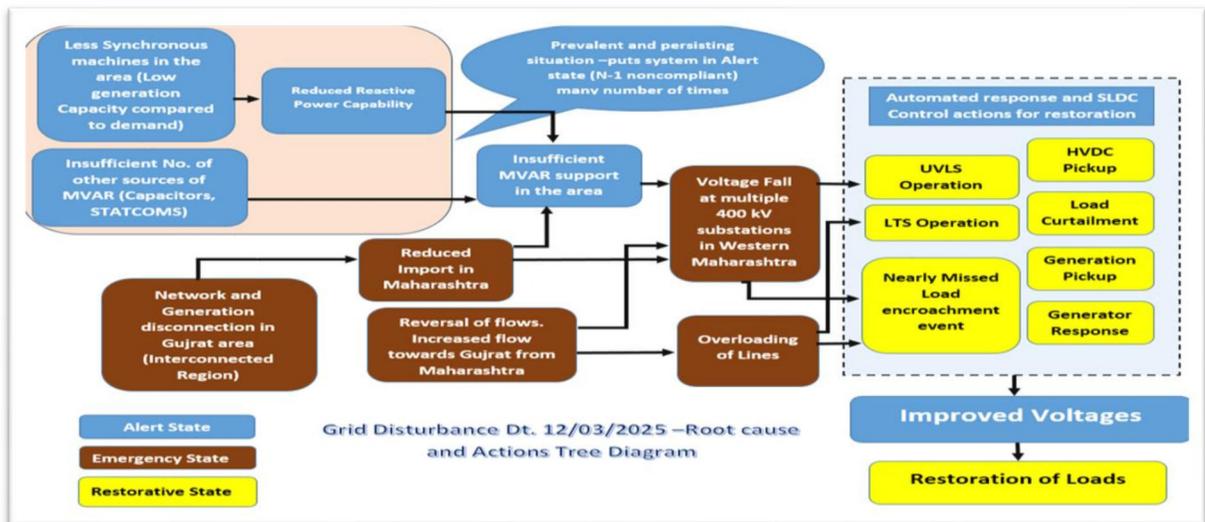
Figure 1: Root cause and action tree diagram

- **Primary Cause:**
  - Multiple transmission lines and generators tripping in **South Gujarat** led to excessive power flow from Maharashtra to Gujarat.
  - Reversal of power flow on key **400 kV transmission corridors** (e.g., **Tarapur–Padghe, Boisar–Padghe**).
  - Severe voltage drops at multiple important 400 kV **substations** from **390 kV to ~350 kV or even less**.
- **Contributing Factors:**
  - Urban load concentration in Mumbai, MMR, Pune, with inadequate transmission infrastructure and less synchronous machine support in this area.
  - Lack of adequate reactive power compensation.
- Heavy pre-existing **line loadings and low system voltages**.

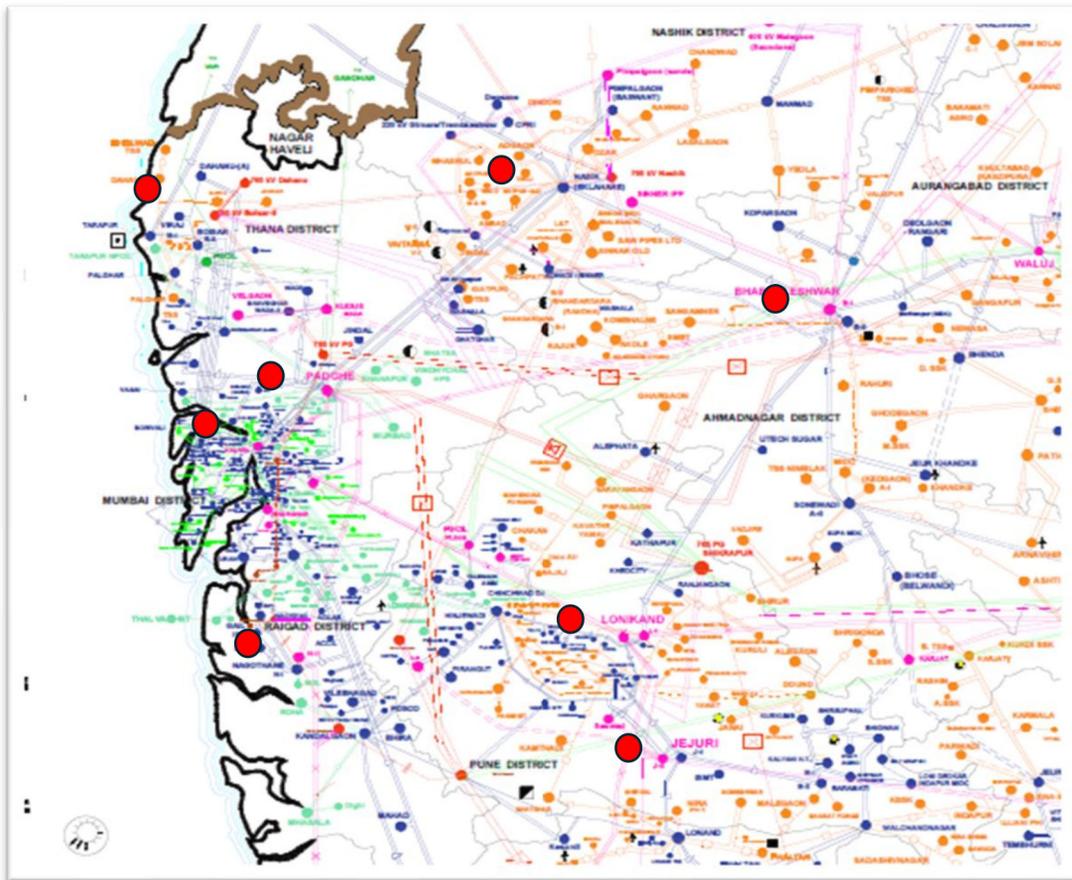
Figure 2: Geographical Area Affected

Affected areas are marked in geographic map shown in Figure – 1 below:

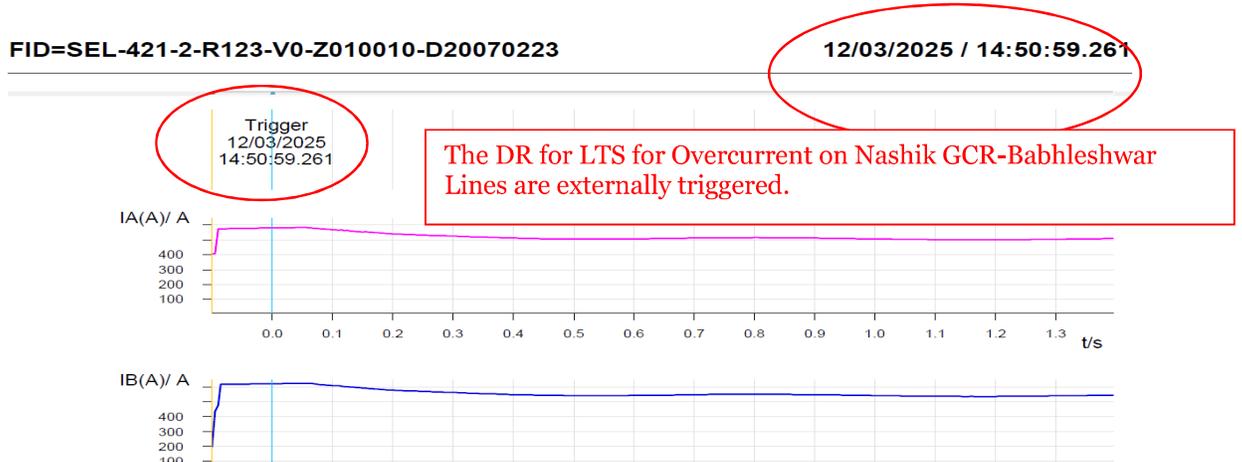
Figure 6: DR 220 kV Nashik GCR – Babhleshwar ckt 1&2 – Overcurrent LTS

DR 220 kV Nashik GCR – Babhleshwar ckt 1&2 – Overcurrent LTS

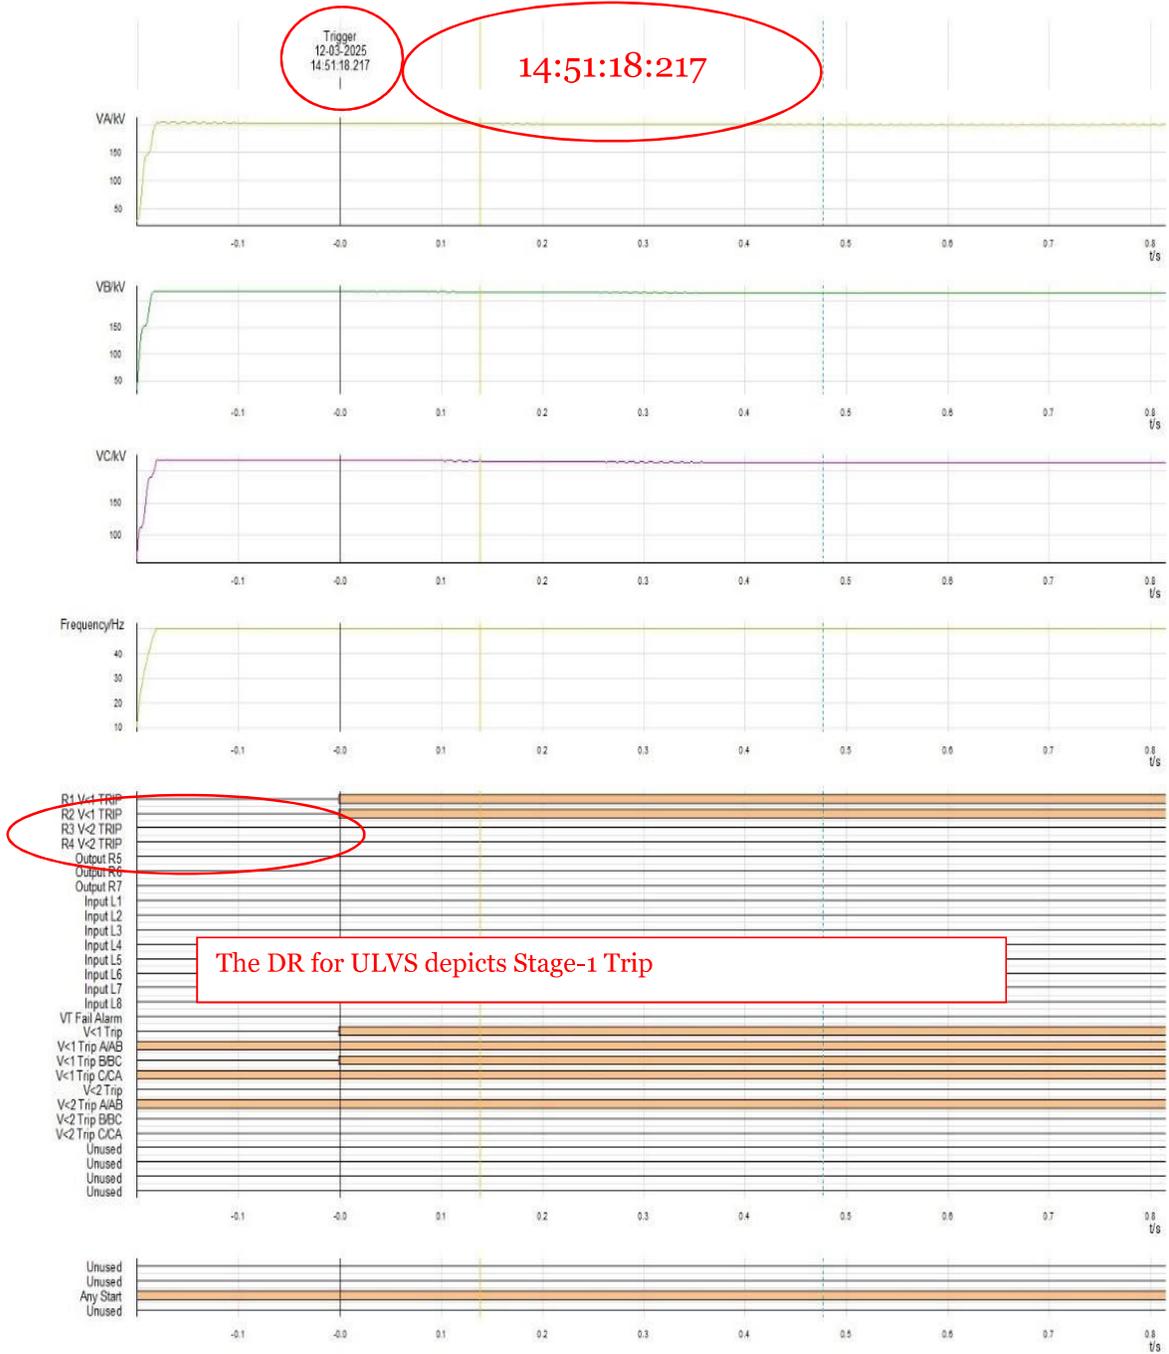
Figure 10: DR 400 kV Padghe – Under Voltage Stage-1 LTS

DR 400 kV Padghe – Under Voltage Stage-1 LTS

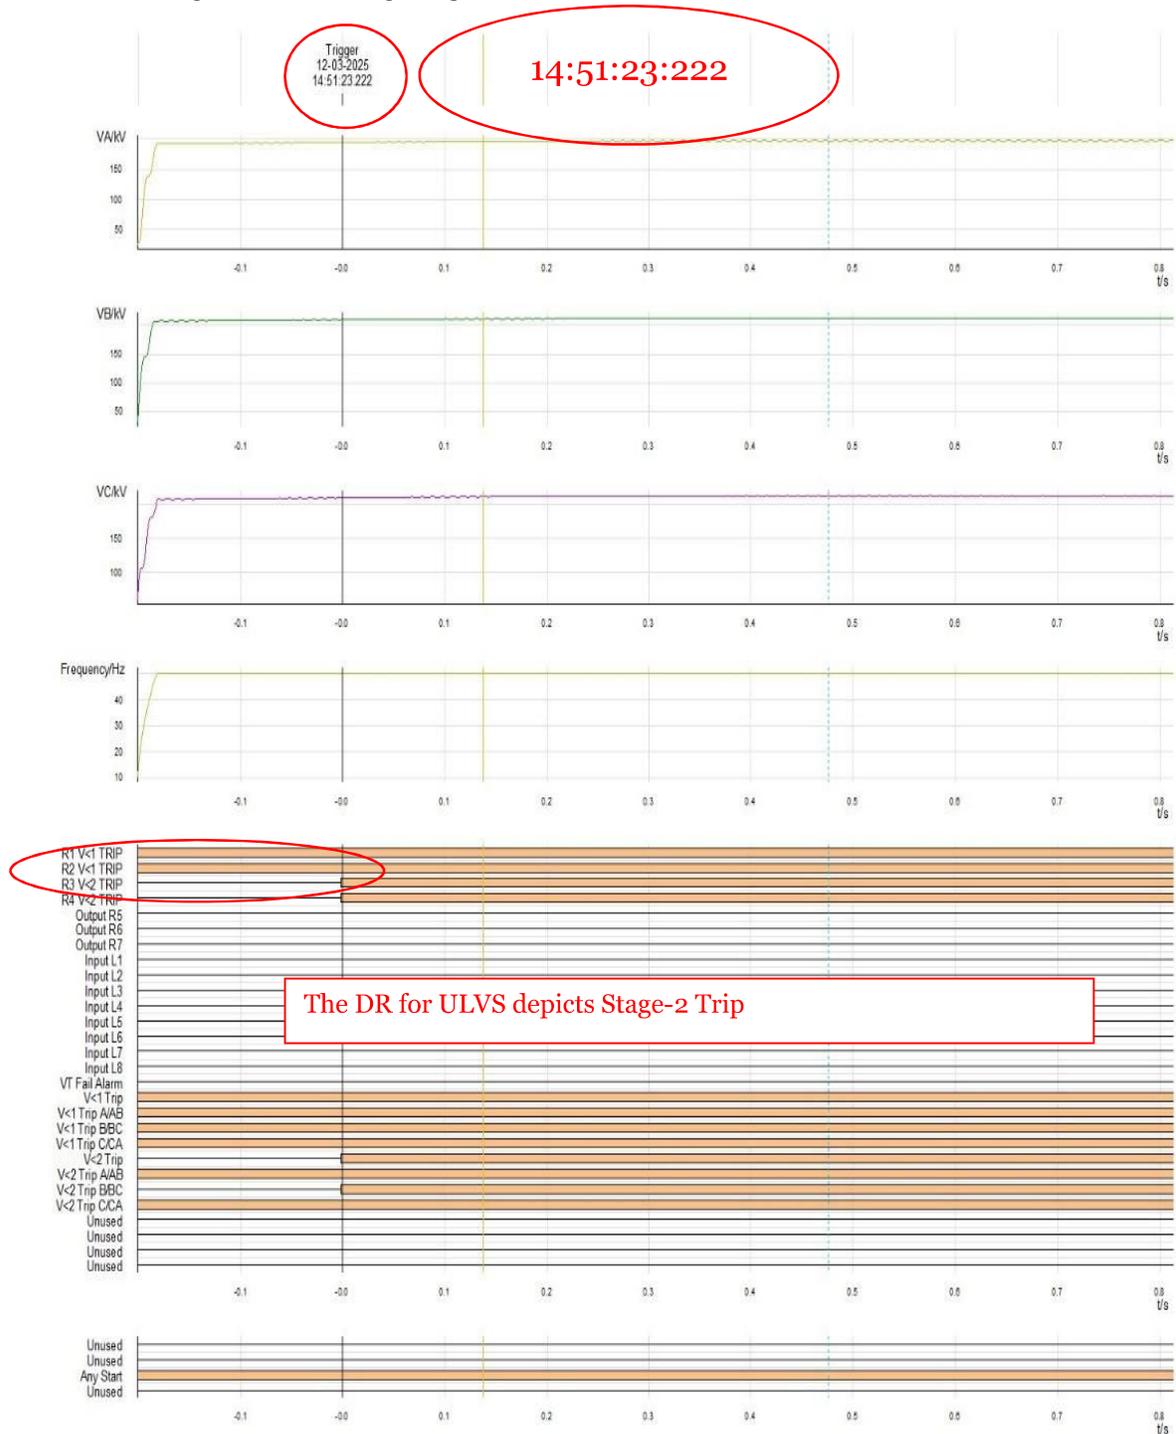
Figure 11: DR 400 kV Padghe – Under Voltage Stage-2 LTS

## DR 400 kV Padghe – Under Voltage Stage-2 LTS

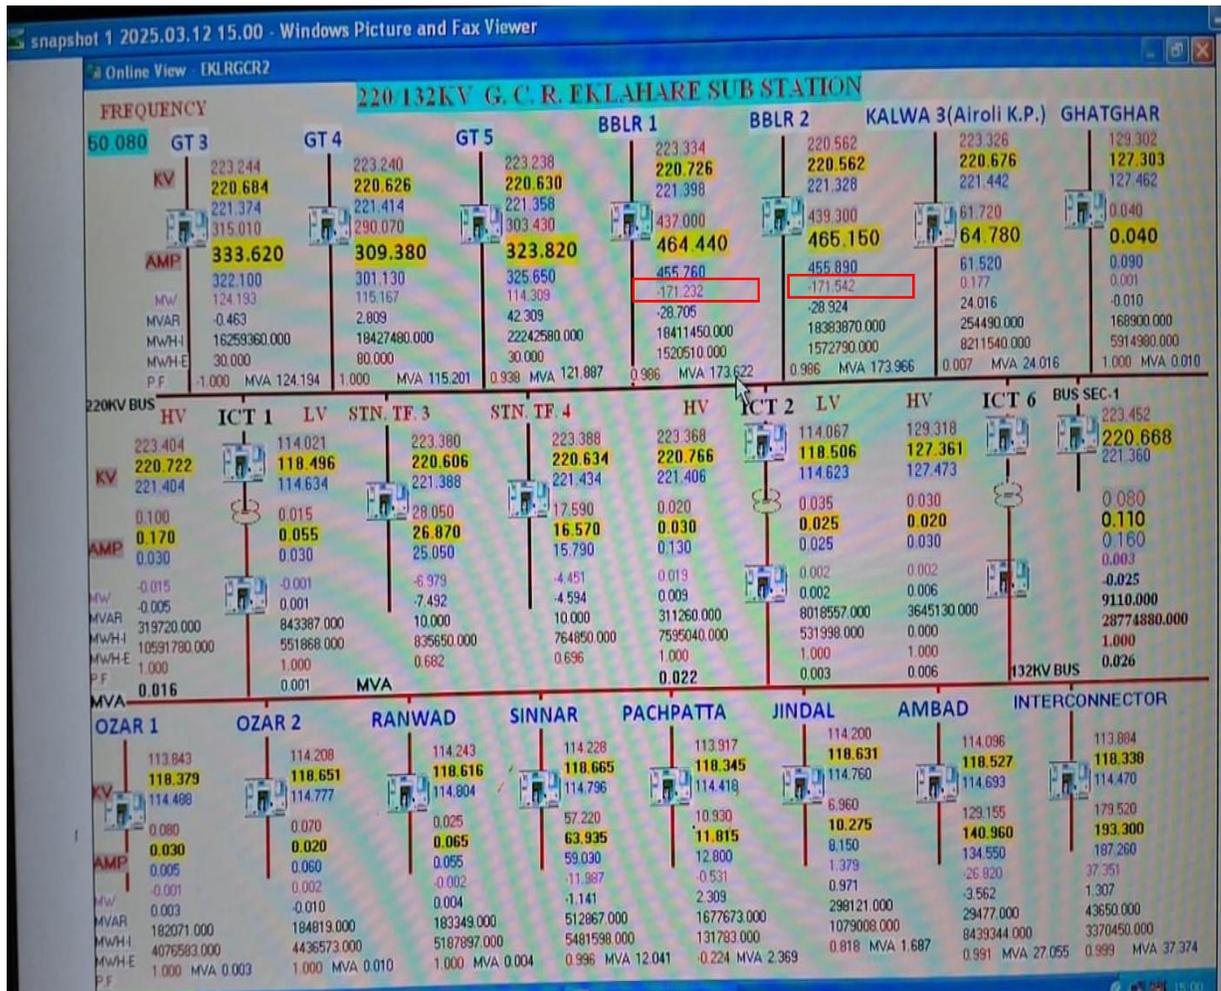
Figure 13: Snap shot of 220 kV OCR substation loadings

**NTPS generation was evacuated through 220kV BBLR 1&2 lines  
(POWER FLOW TOWARDS BABHLESHWAR)**

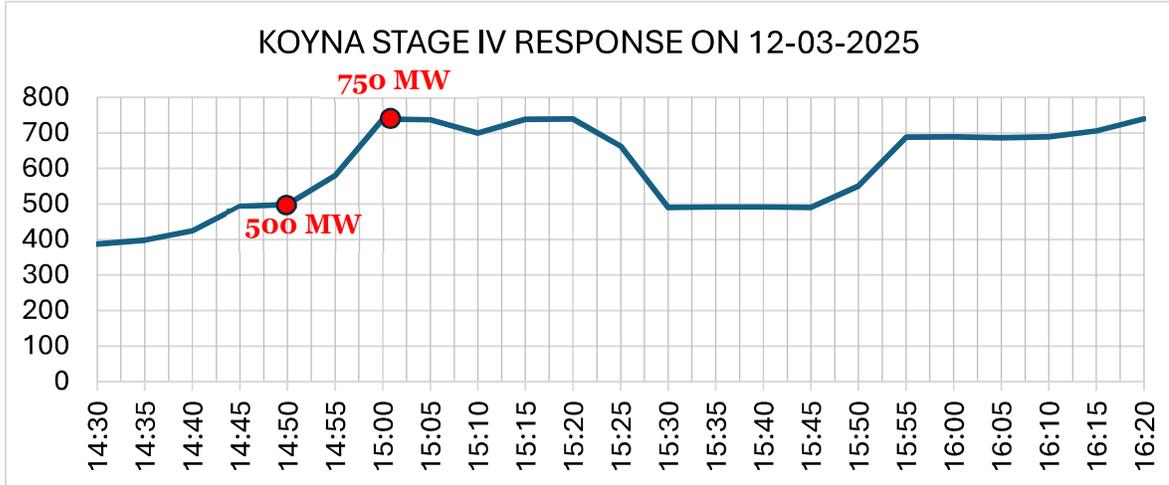
Figure 14: KOYNA STAGE IV RESPONSE ON 12-03-2025

At 15:25 hrs, Koyna stage-IV Unit-1 (250 MW) withdrawn due to downstream seal leakage observed. Generation decreased from 750 MW to 500 MW.

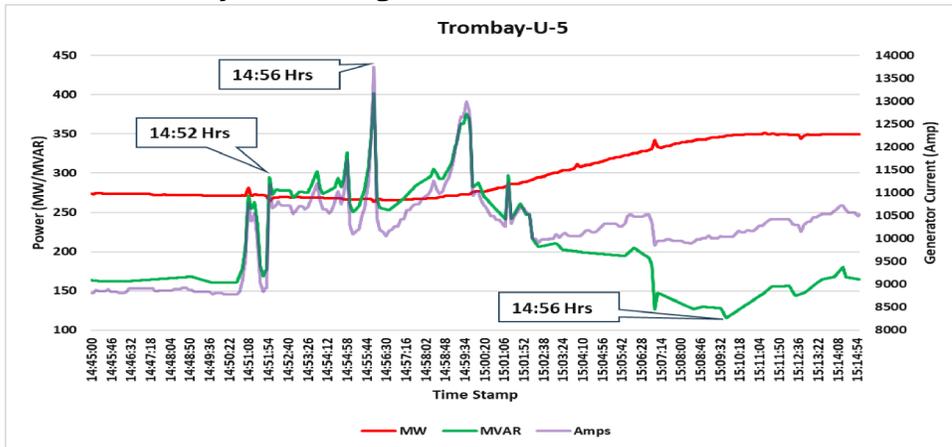
Figure 47 Trombay Unit-5 (500 MW): P, Q & Gen Current (Source: TPCL)

From the above, plot, it is observed that the Trombay Unit-5 supported the Grid by injecting Reactive Power. In Unit-5 Max Generator current recorded was 13755 amps for a very short duration reflected as a spike seen in the plot. The rated full load current is 10640 amps. In such case, there was possibility of loss of this unit if such overloading had continued.

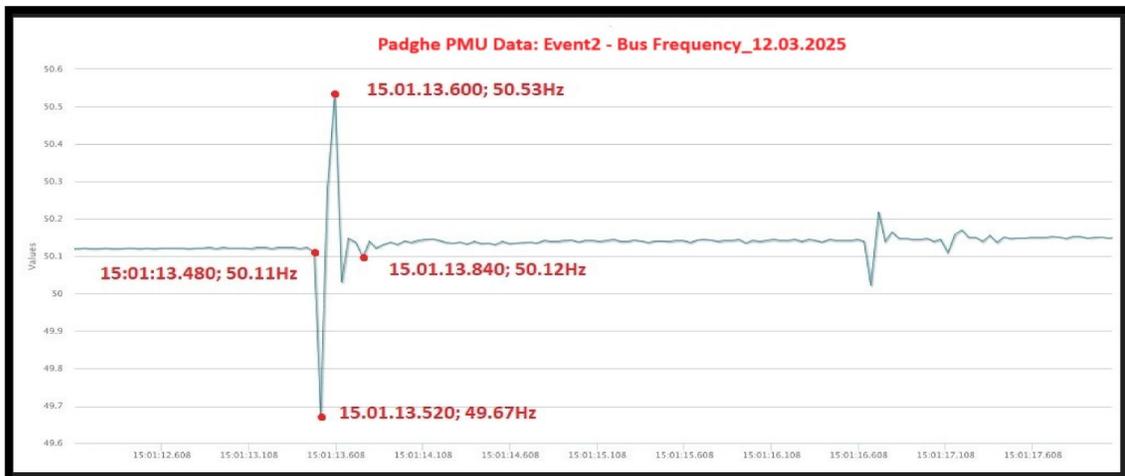
Figure 64 frequency deviation during event 3

At 15:01:13.600 hrs frequency reached to 50.53 Hz, whereas at 15:01:13.840 hrs (after 240ms) frequency dropped to 50.12 Hz.

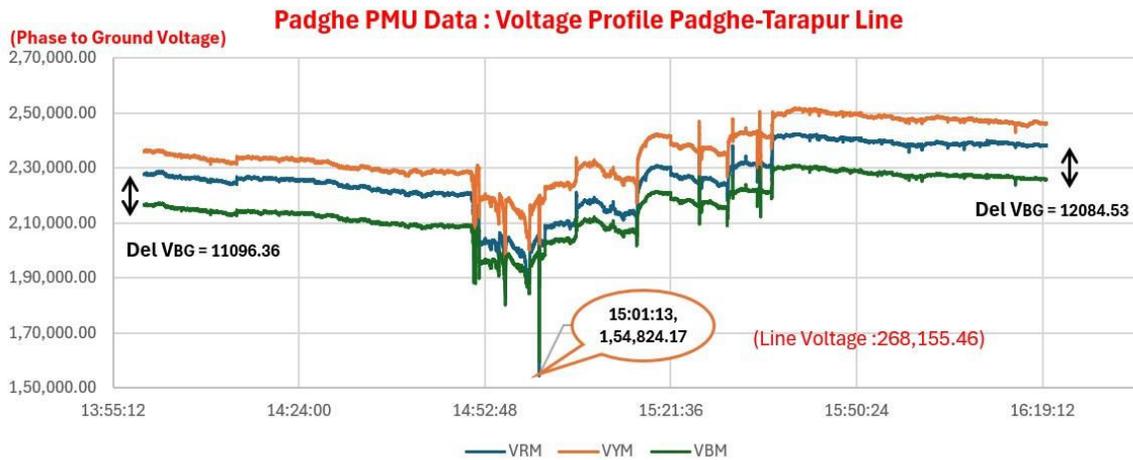
Figure 72 Phase to Ground Voltage plot at 400 kV Padghe (PMU)

The Phase to Ground Voltage plot at 400 kV Padghe bus is shown below:

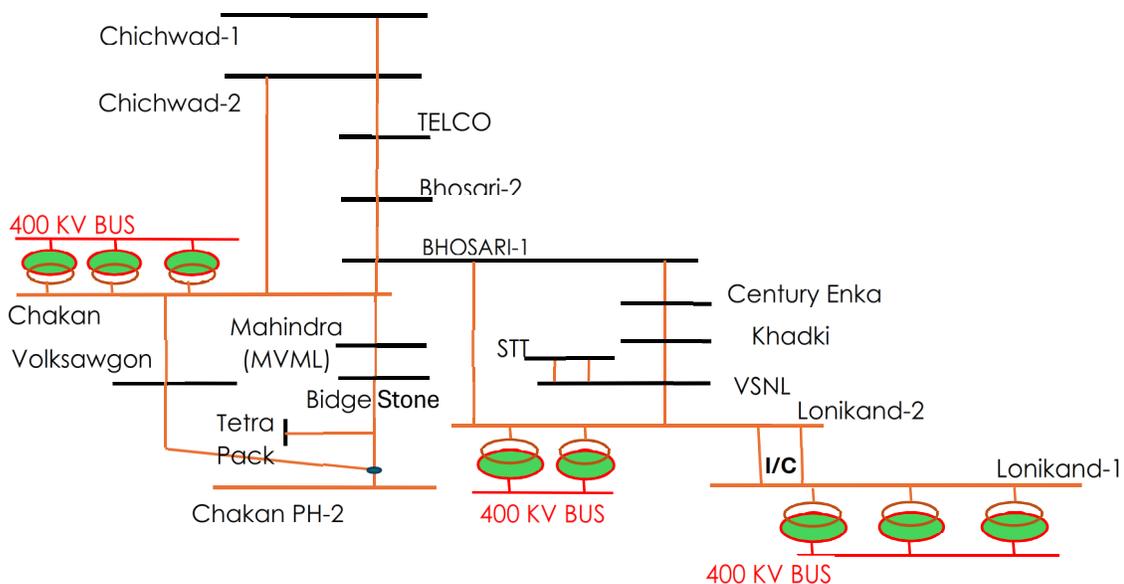
Figure 81 220 kV Network around 220 kV Bhosari-1 ss.

220 kV Bhosari-1 ss is a major load centre in Pune area. It is connected to 400 kV Chakan ss & 400 kV Lonikand ss via 220 kV Lines. 220 kV Bhosari-1 ss, caters urban residential, industrial loads of @ 130 MW in Pune region.

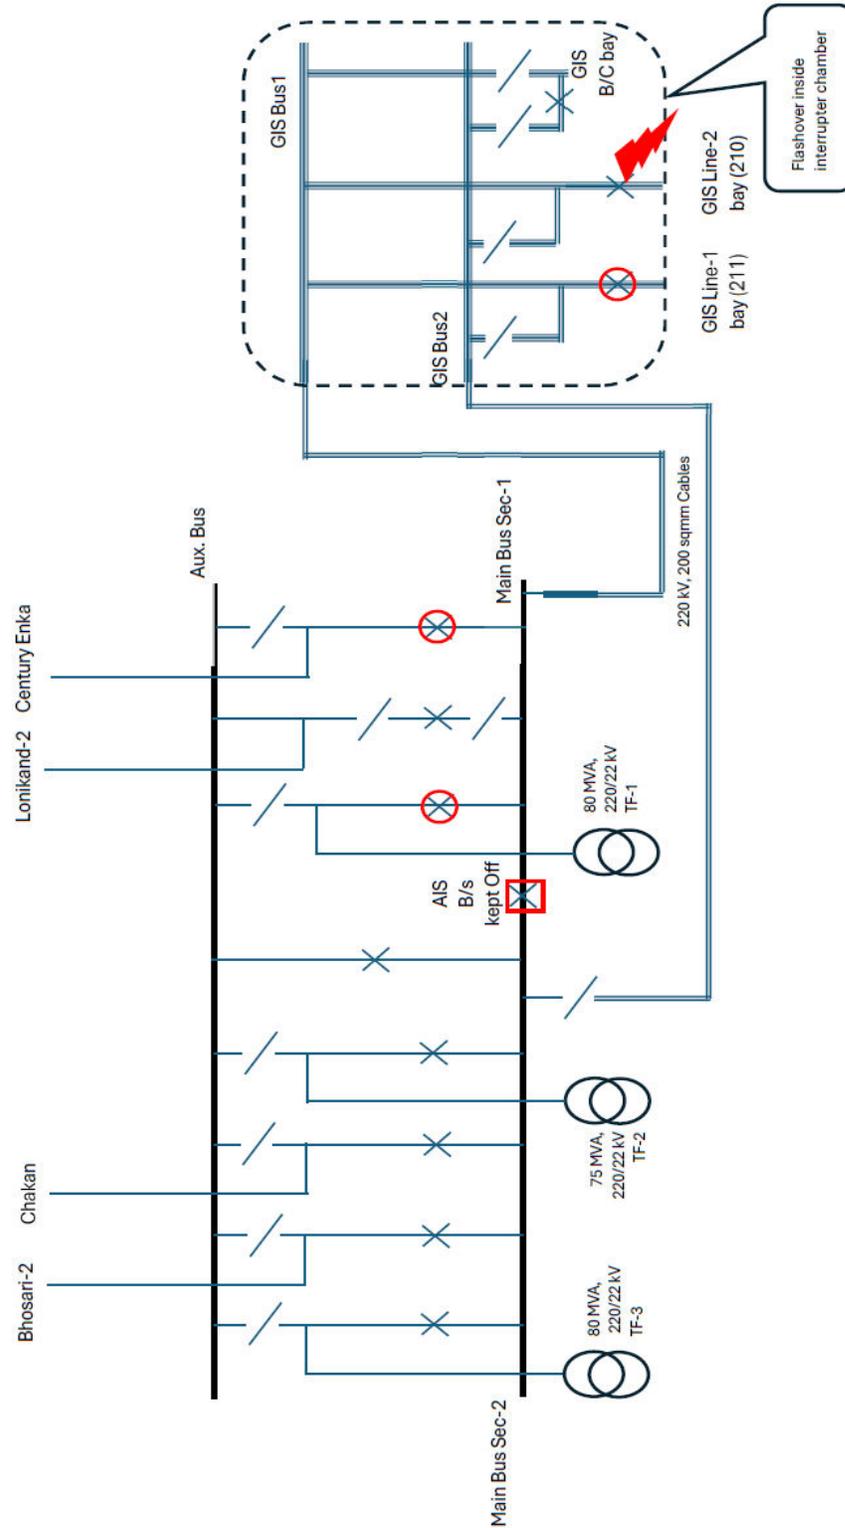
Figure 82 Occurrence of 220 kV busbar bar protection operation at 220 kV Bhosari 1 substation during FTC of 220 kV GIS Microsoft Bay 210 on 18.06.2025.

**SLD for 220 kV Busbar prot.operation at 220kV Bhosari-1 ss during first-time charging of 220 kV GIS MicroSoft Bay (210) on 18.06.2025.**

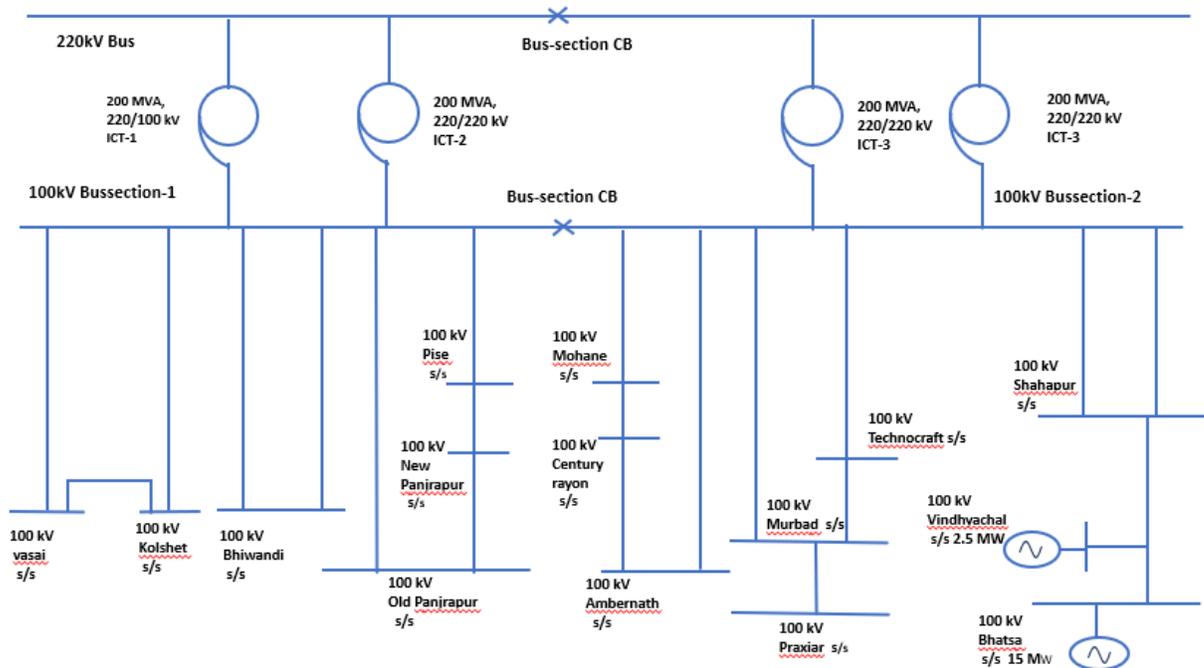
Fig:1 - Network around 100kV Padgha ss.

Padgha's 100 kV system also feeds vital water supply installations at 100kV Pise, 100kV Old and 100kV New Panjrapur s/s. These substations supply power to water pumping and purification stations responsible for Mumbai and Thane's water supply.

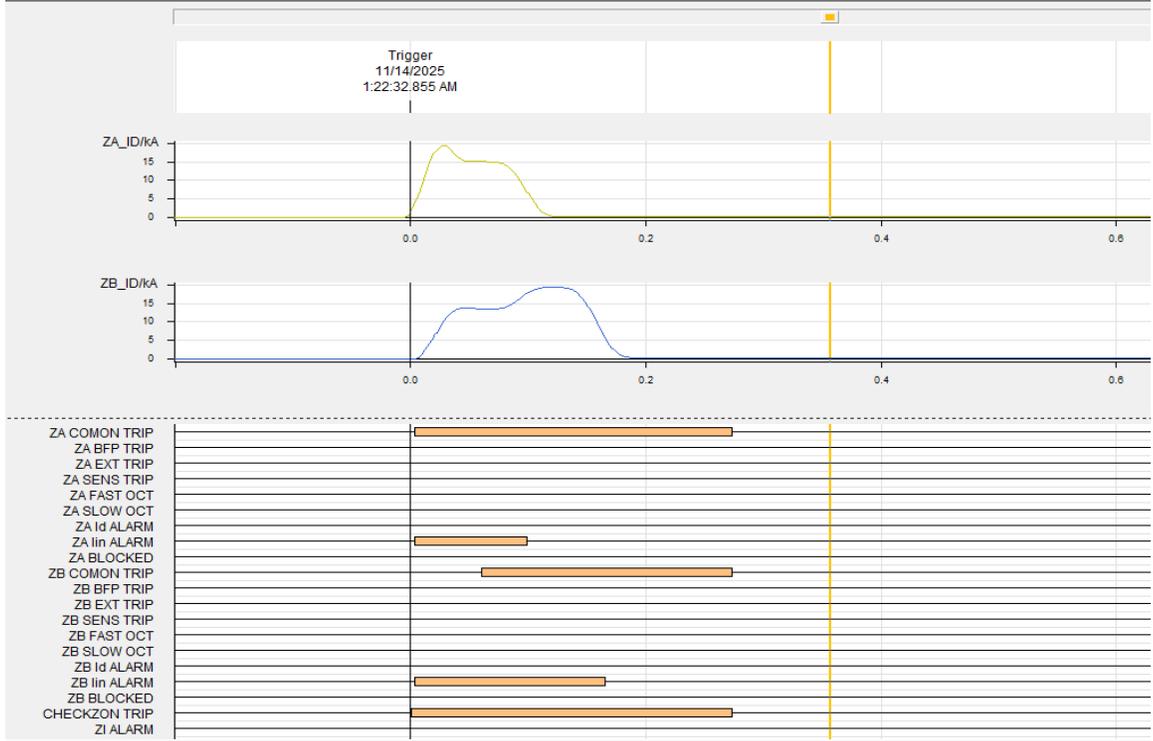
Figure 110 Busbar relay DR On 14.11.2025 at 02:22 hrs,

iii. Busbar relay DR On 14.11.2025 at 02:22 hrs,

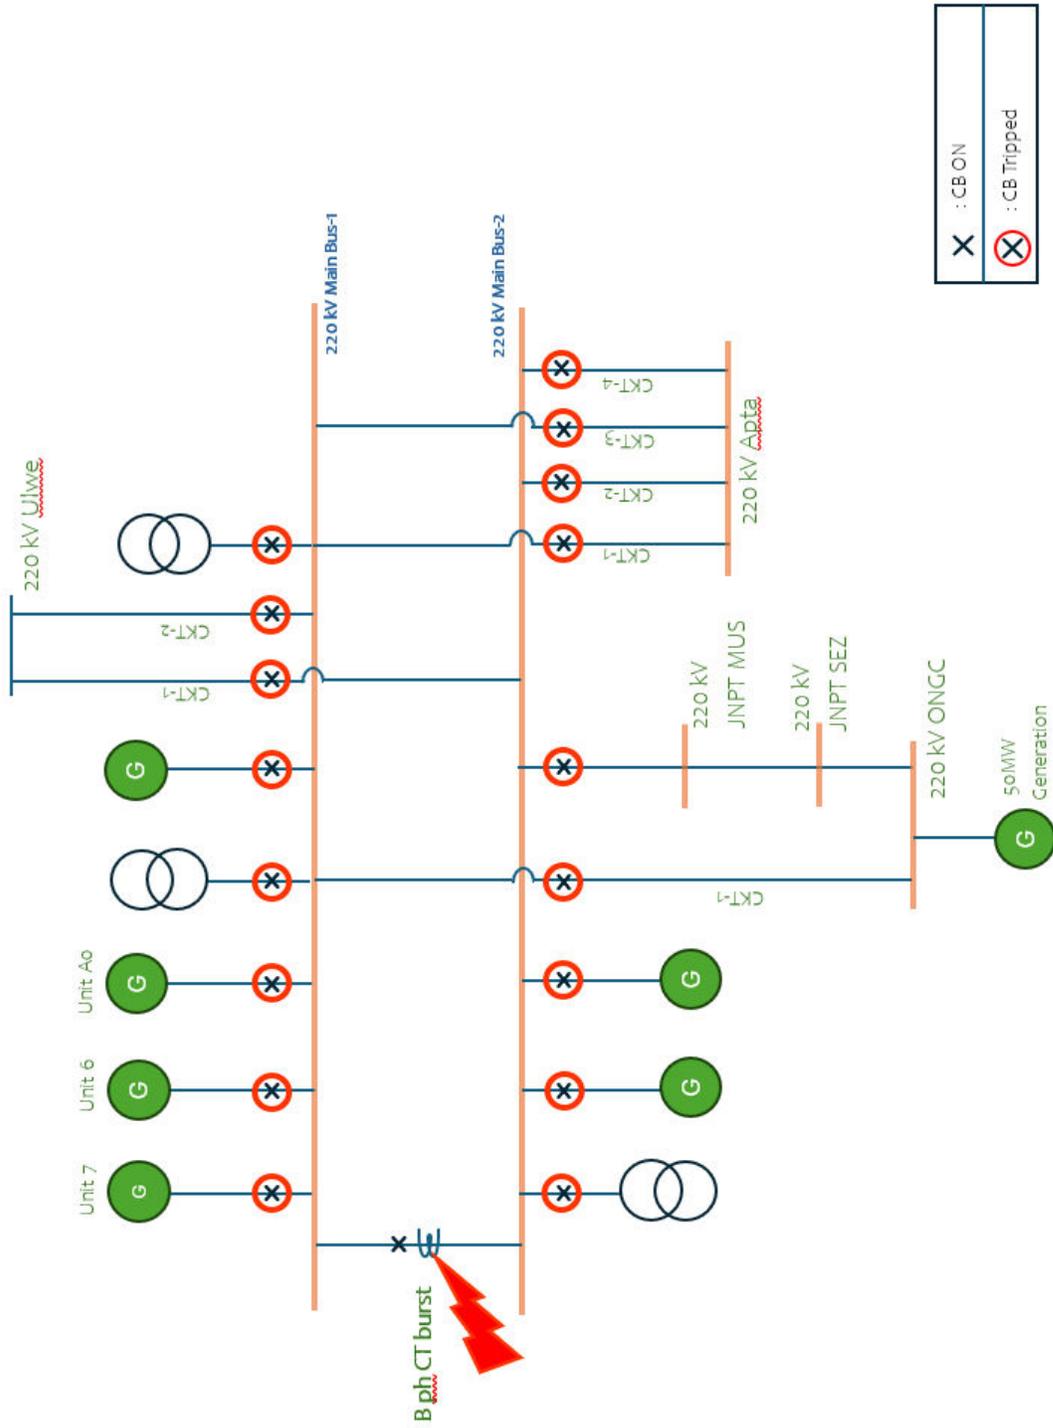
Figure 111 SLD of occurrences on 220 kV Main Bus-I & II Busbars at 220KV Uran substation on 14.11.2025.

**SLD of occurrences on 220 kV Main Bus-I & II Busbars at 220KV Uran substation on 14.11.2025.**
